# Environmental Due Diligence Report

Document stage: Draft for Consultation  
Project Number: 49107-009  
June 2021

## INDIA: Integrated Urban Flood Management of the Chennai-Kosasthalaiyar Basin Project

(Infection Prevention and Control of COVID-19  
through Wash Services Improvement for Integrated  
Pandemic and Disaster Risk Management for the  
Urban Poor in Chennai in Kosasthalaiyar Basin under  
JFPR Grant)

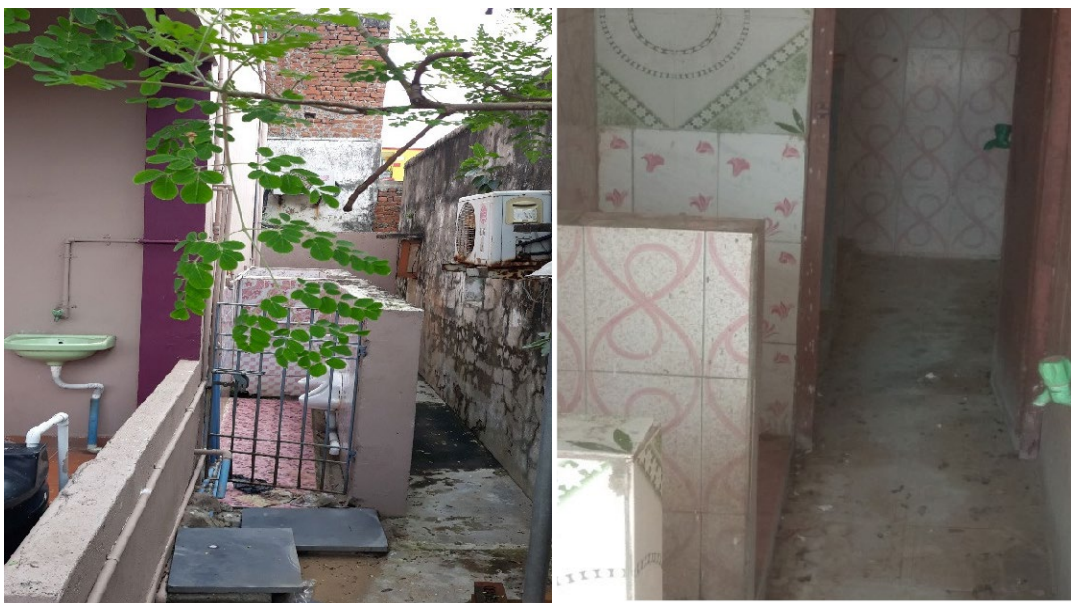
16. **Toilet Facilities.** Around 40 to 60% of school toilets are having accessibility, functionality, privacy and cleanliness standards in line with the National WaSH Standards. Some schools are provided with new toilet facilities with the help of the NGOs. 4 schools with disabled children but not having disabled friendly toilets have been identified. Around 30% of the schools do not have area for construction of additional toilet blocks. The toilets use septic tanks / soak pit arrangements in areas where the sewage lines are not directly connected to the system.

| Output | Components | Design Considerations for the Proposed Interventions |
|---|---|---|
| | Toilets | <ul style="list-style-type: none"> <li>• Toilets doors should be repaired and checked for locks</li> <li>• There should be a separate water storage for the toilet in concrete (secured). Even precast can be considered to expedite the construction. However, the structure should be able to take up the tank which has to be provided</li> <li>• All the water pipelines have to be concealed into walls and not exposed (secured). If the pipeline has to be exposed it should be made of galvanized iron (GI) and properly secured.</li> <li>• All the toilets should have taps and the taps shall be made of GI / High strength plastic.</li> <li>• The sewage pipe line should be re-designed properly with the large services access (pits) and correct flow levels. This is to avoid clogging of toilet sewage pipeline</li> <li>• Most of the schools have the sewage sump and some of the sumps are to be repaired and properly sealed</li> <li>• Floor and wall tilling work of most of toilets has to be repaired</li> </ul> |

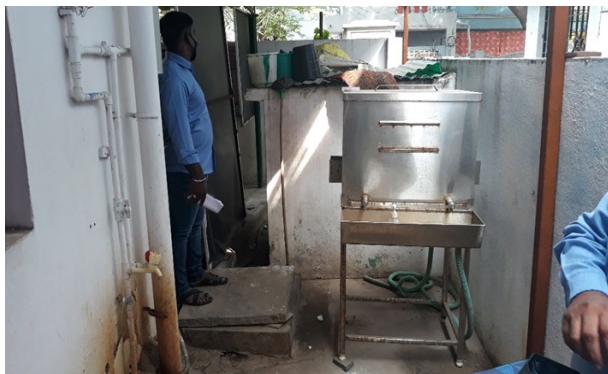
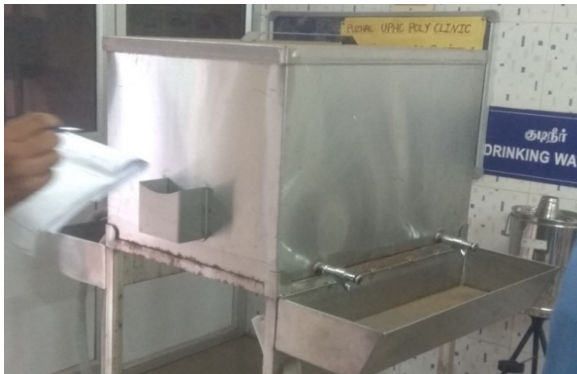
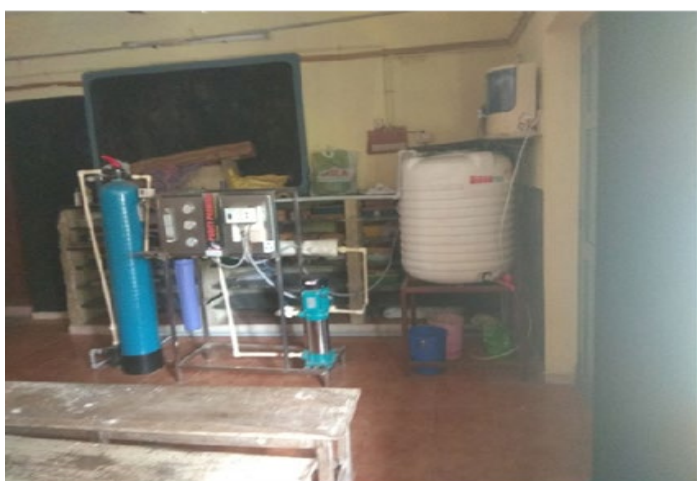
18. **Drinking water Facility.** Around 90% of the schools are having RO system for treating the water, which is supplied either by the Chennai metro water or individual bore well. However, it was observed that nearly 30 to 40% of the RO system is not functioning.

| Output | Components | Design Considerations for the Proposed Interventions |
|---|---|---|
| | Drinking water | <ul style="list-style-type: none"> <li>RO water treatment system has to be repaired for filters, motors and pipelines.</li> <li>Water dispensing station made of stainless should be provided with proper tap and drain.</li> <li>In addition to the hand operated piped drinking water dispensing facility foot operated drinking water dispensing facility also to be provided to accommodate the COVID19 requirements.</li> </ul> |

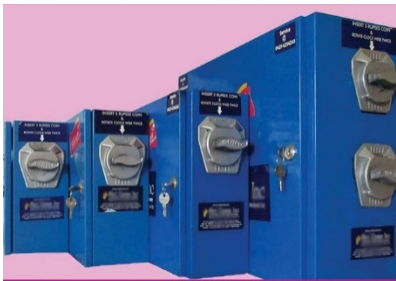
| Output | Components | Design Considerations for the Proposed Interventions |
|---|---|---|
| | Menstrual hygiene management (MHM) | <ul style="list-style-type: none"> <li>A separate privacy room for menstrual hygiene management should be provided for all the 30 schools having classes from class 6 (grade 5).</li> <li>The privacy room shall be provided with an incinerator with exhaust, hand wash basin with proper water inlet and proper outlet with closed drainage and a menstrual pad dispenser</li> <li>The wall and floor shall be tiled and should be designed for easy maintenance.</li> <li>Incinerators for sanitary pad disposal to be provided</li> <li>Incinerators' capacity will be from five to 10 napkin pads per cycle with a minimum of 200 pads per day. Incinerators, having a length of 2.5 meters, also come with thermally insulated front door. Emission outlets of the incinerators include a metal pipe exhaust on top and flexible steel hose of a minimum length of two meter with clamp provision.</li> <li>Complete burning of napkins only less than 1 g ash per napkin is generated. The exhaust gas meets the solid waste management rules 2016/CPCB guidelines.</li> <li>Ash collection with easily openable and ash disposable</li> </ul> <p><b>(Representative image) Incinerator</b></p> |

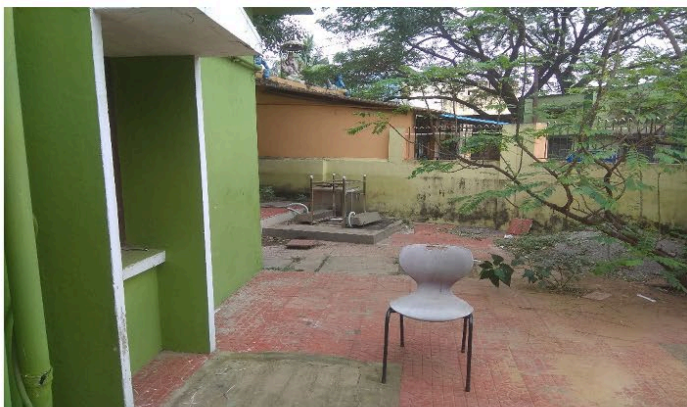
Handwash (Totally neglected condition)

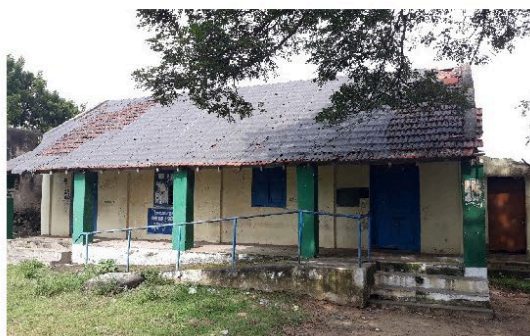
**Very poor building condition with huge roof leak**
