# Environmental Due Diligence Report

Document stage: Draft for Consultation

**INDIA: Integrated Urban Flood Management of the Chennai-Kosasthalaiyar Basin Project – Additional Financing**

**Infection Prevention and Control of COVID-19 and Other Communicable Diseases through WASH Services for the Urban Poor (JFPR Grant)**

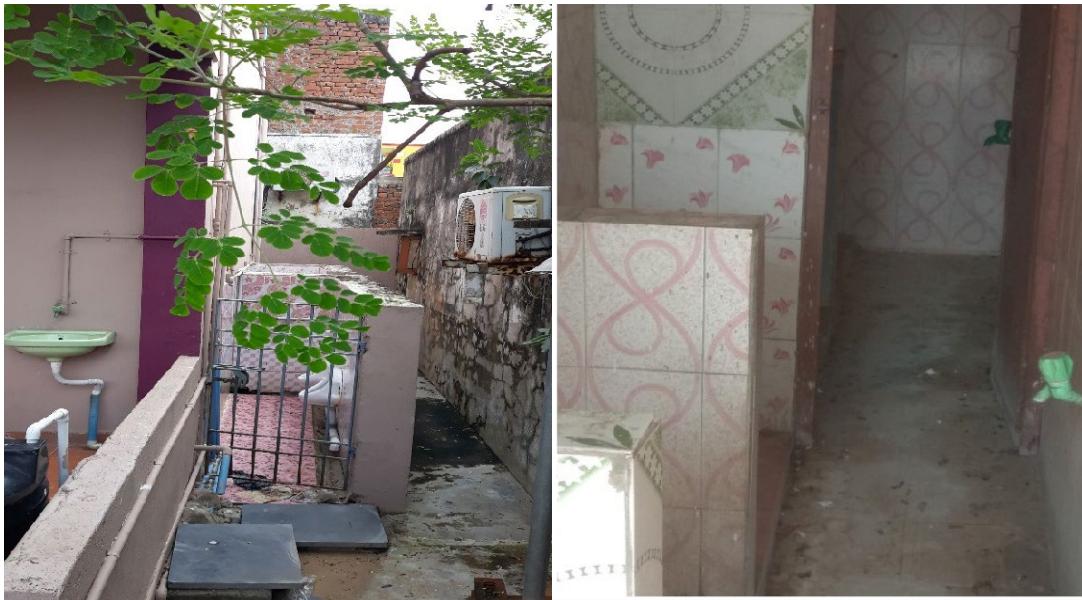
16. **Toilet Facilities.** Around 40 to 60% of school toilets are having accessibility, functionality, privacy and cleanliness standards in line with the National WaSH Standards. Some schools are provided with new toilet facilities with the help of the NGOs. 4 schools with disabled children but not having disabled friendly toilets have been identified. Around 30% of the schools do not have area for construction of additional toilet blocks. The toilets use septic tanks / soak pit arrangements in areas where the sewage lines are not directly connected to the system.

Output	Components	Design Considerations for the Proposed Interventions
	Toilets	<ul style="list-style-type: none"> <li>Toilets doors should be repaired and checked for locks</li> <li>There should be a separate water storage for the toilet in concrete (secured). Even precast can be considered to expedite the construction. However, the structure should be able to take up the tank which has to be provided</li> <li>All the water pipelines have to be concealed into walls and not exposed (secured). If the pipeline has to be exposed it should be made of galvanized iron (GI) and properly secured.</li> <li>All the toilets should have taps and the taps shall be made of GI / High strength plastic.</li> <li>The sewage pipe line should be re-designed properly with the large services access (pits) and correct flow levels. This is to avoid clogging of toilet sewage pipeline</li> <li>Most of the schools have the sewage sump and some of the sums are to be repaired and properly sealed</li> <li>Floor and wall tilling work of most of toilets has to be repaired</li> <li>Internal and external wall has to be repainted to keep the toilets clean.</li> </ul>

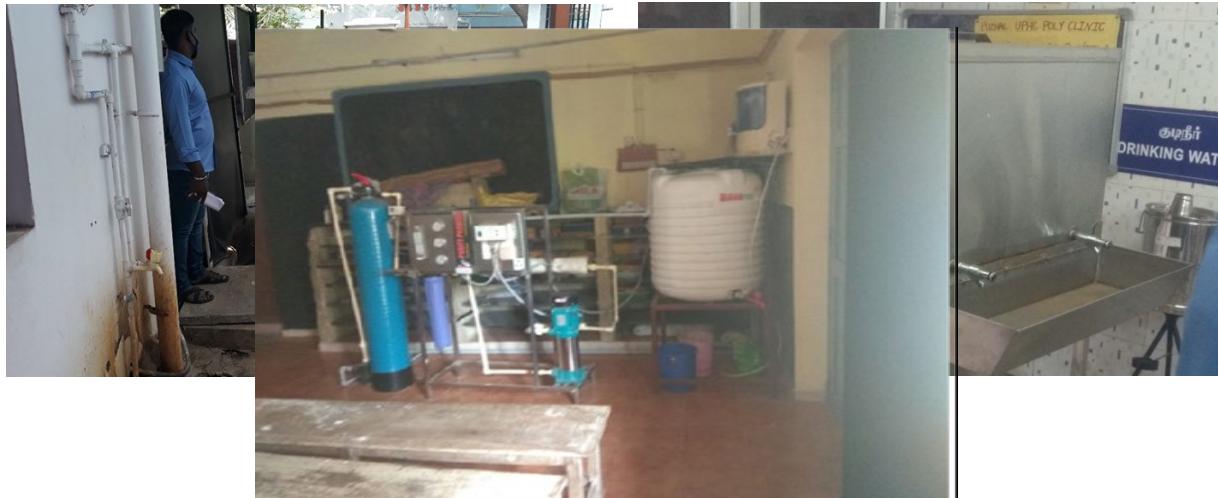
18. **Drinking water Facility.** Around 90% of the schools are having RO system for treating the water, which is supplied either by the Chennai metro water or individual bore well. However, it was observed that nearly 30 to 40% of the RO system is not functioning.

Drinking water	<ul style="list-style-type: none"> <li>RO water treatment system has to be repaired for filters, motors and pipelines.</li> <li>Water dispensing station made of stainless should be provided with proper tap and drain.</li> <li>In addition to the hand operated piped drinking water dispensing facility foot operated drinking water dispensing facility also to be provided to accommodate the COVID19 requirements.</li> </ul>

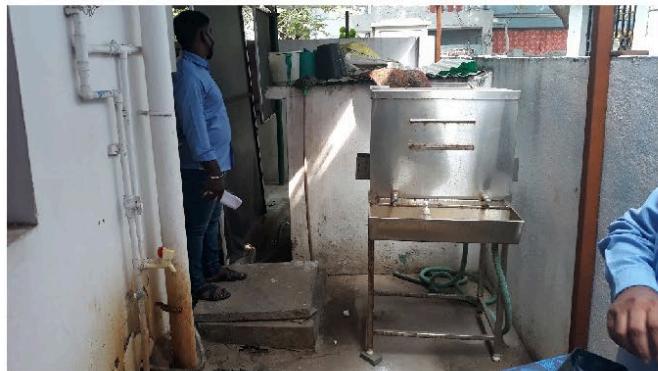
Handwash

#	Issues addressed	Remark
1	Hand wash facility and type	Conventional tap with soap
2	Number of outlets	4
3	Condition	The hand wash apparatus has been used but not kept clean. Improper drainage for used water. This may by itself pose a health hazard.

- Staff must be trained as well as supervised to adhere to WaSH norms and disciplinary action initiated in case of failure to follow laid down SOP with regards to washing hands, insisting on the patients who come to wash hands and follow protocol as well as regarding wearing Masks.
- The asset for hand wash has been abused by improper use. Running water connectivity and proper drainage for the same not provided. Sensitization of the staff on its importance and utilization must be insisted and followed up.
- Handicap Ramp not provided as the entrance is at lower level. But convenience for such persons can be provided.

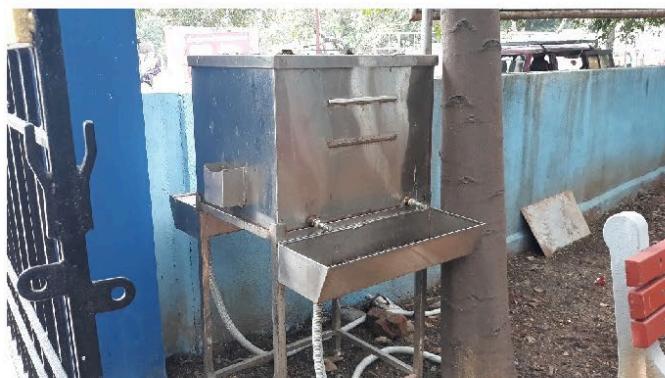
Handwash

#	Issues addressed	Remark
1	Hand wash facility and type	Conventional tap with soap
2	Number of outlets	4
3	Condition	The hand wash apparatus has been used but not kept clean. This may by it self pose a health hazard.

- Staff must be trained as well as supervised to adhere to WaSH norms and disciplinary action initiated in case of failure to follow laid down SOP with regards to washing hands, insisting on the patients who come to wash hands and follow protocol as well as regarding wearing Masks.
- The asset for hand wash has been abused by improper use. Running water connectivity and proper drainage for the same not provided. Sensitization of the staff on its importance and utilization must be insisted and followed up.
- Did not see a Ramp facility and the facility can be improved to include facilities for Handicapped persons with minor modifications.

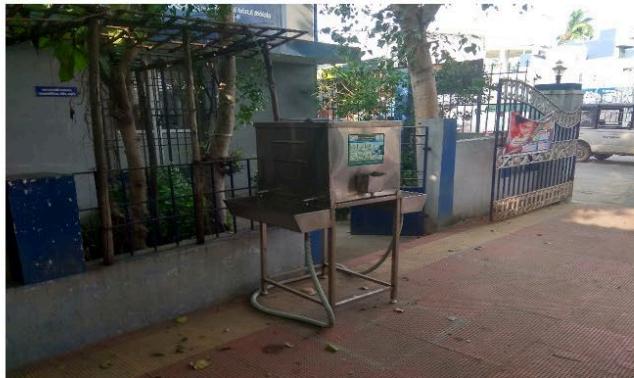
Handwash

#	Issues addressed	Remark
1	Hand wash facility and type	Conventional tap with soap
2	Number of outlets	4
3	Condition	The hand wash apparatus has been used but not kept clean. This may by it self pose a health hazard.

- Staff must be trained as well as supervised to adhere to WaSH norms and disciplinary action initiated in case of failure to follow laid down SOP with regards to washing hands, insisting on the patients who come to wash hands and follow protocol as well as regarding wearing Masks.
- The asset for hand wash has been abused by improper use. Running water connectivity and proper drainage for the same not provided. Sensitization of the staff on its importance and utilization must be insisted and followed up.
- Did not see a Ramp facility and the facility can be improved to include facilities for Handicapped persons with minor modifications.

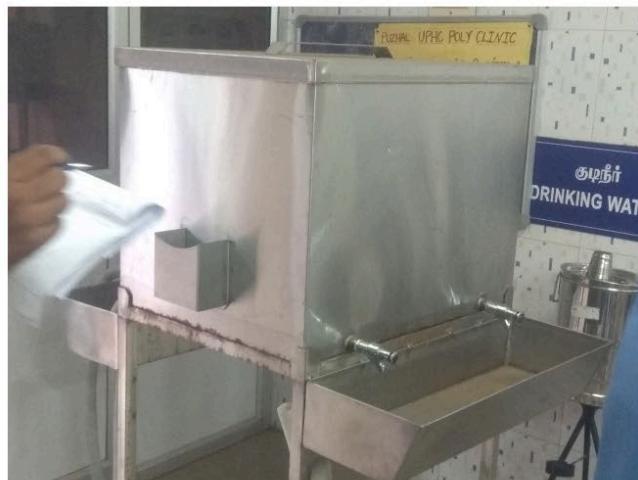
Handwash

#	Issues addressed	Remark
1	Hand wash facility and type	Conventional tap with soap
2	Number of outlets	4
3	Condition	The hand wash apparatus has been used and kept clean. Probably one of the few UPHC where it is used properly.

- Staff must be trained as well as supervised to adhere to WaSH norms and disciplinary action initiated in case of failure to follow laid down SOP with regards to washing hands, insisting on the patients who come to wash hands and follow protocol as well as regarding wearing Masks.
- The asset for hand wash has been utilized properly. Running water connectivity and proper drainage for the same is provided. Sensitization of the staff on its importance and utilization must be insisted and followed up.
- Ramp for handicapped persons provided.

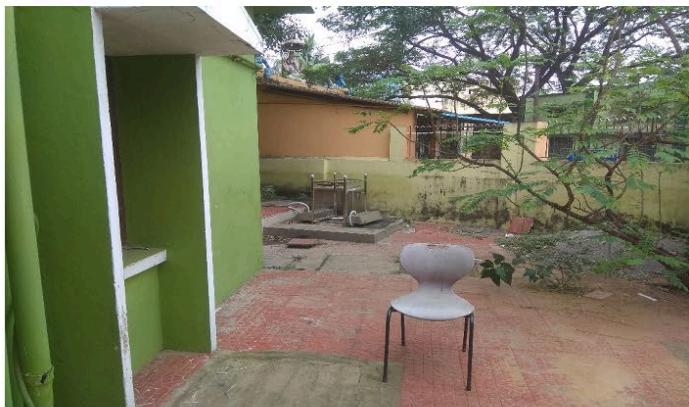
Zone	03 - Madhavaram
Division	26
School Name	UPHC
Location	Swamy Nagar, Madhavaram

Handwash (Totally neglected condition)

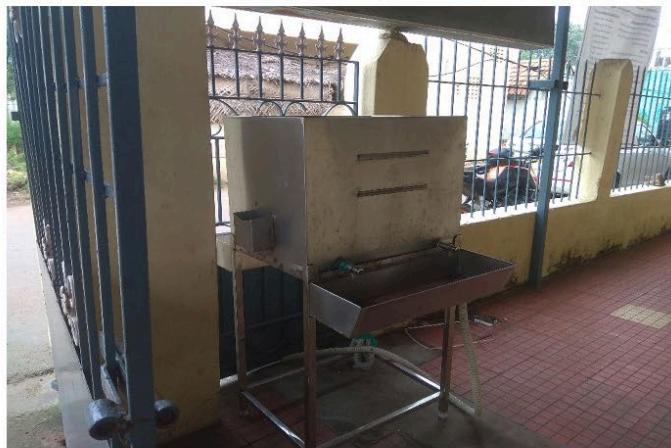
Handwash

#	Issues addressed	Remark
1	Hand wash facility and type	Conventional tap with soap
2	Number of outlets	4
3	Condition	The hand wash apparatus has not been used.

- a. Staff must be trained as well as supervised to adhere to WaSH norms and disciplinary action initiated in case of failure to follow laid down SOP with regards to washing hands, insisting on the patients who come to wash hands and follow protocol as well as regarding wearing Masks.
- b. The asset for hand wash has not been used. Running water connectivity and proper drainage for the same not provided. Sensitization of the staff on its importance and utilization must be insisted and followed up.
- c. Metro water connectivity may be provided at the earliest.

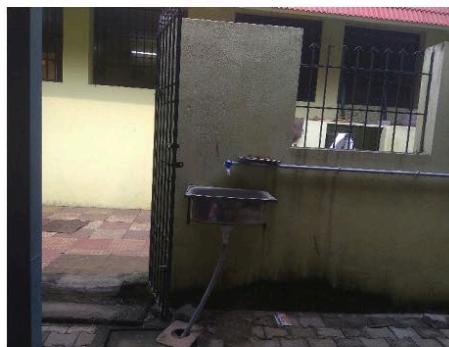
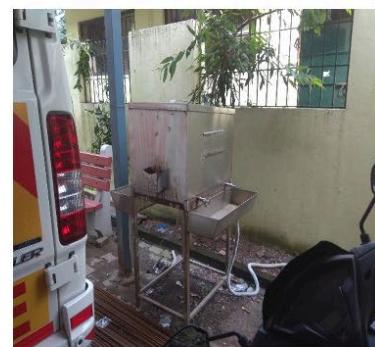
#	Issues addressed	Remark
1	Hand wash facility and type	Conventional tap with soap
2	Number of outlets	4 + 1
3	Condition	The hand wash apparatus has been used but not kept clean. This may by it self pose a health hazard. 1 SS Washbasin with running water and proper drainage is available for Washing hands

Handwash (4 outlet not being used properly)

- Staff must be trained as well as supervised to adhere to WaSH norms and disciplinary action initiated in case of failure to follow laid down SOP with regards to washing hands, insisting on the patients who come to wash hands and follow protocol as well as regarding wearing Masks.
- The asset for hand wash has been abused by improper use. Running water connectivity and proper drainage for the same not provided. Sensitization of the staff on its importance and utilization must be insisted and followed up.
- Ramp for handicapped persons not provided as the entrance is on flat ground. However, more comfortable services can be provided for such persons.

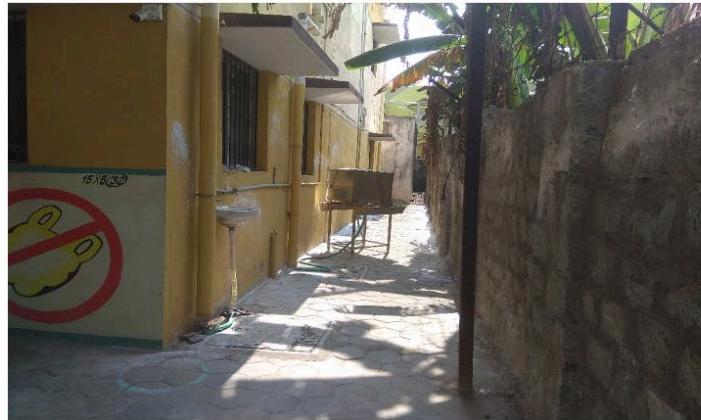
Hand Wash

#	Issues addressed	Remark
1	Hand wash facility and type	Conventional tap with soap
2	Number of outlets	4 + 1
3	Condition	The hand wash apparatus has not been used. Only wash basin being used.

- Staff must be trained as well as supervised to adhere to WaSH norms and disciplinary action initiated in case of failure to follow laid down SOP with regards to washing hands, insisting on the patients who come to wash hands and follow protocol as well as regarding wearing Masks.
- The asset for hand wash has not been used. Running water connectivity and proper drainage for the same not provided. Sensitization of the staff on its importance and utilization must be insisted and followed up.
- Metro water connectivity may be provided at the earliest.

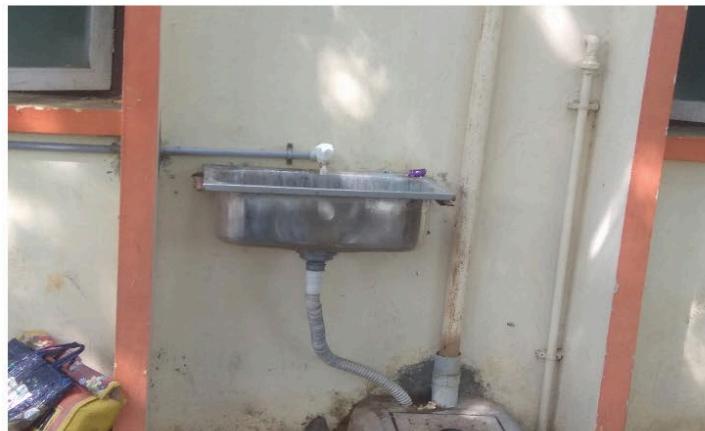
Handwash

#	Issues addressed	Remark
1	Hand wash facility and type	Conventional tap with soap
2	Number of outlets	2
3	Condition	The hand wash apparatus has not been provided for this UPHC. They are using the available resources in an optimal way.

- Staff must be trained as well as supervised to adhere to WaSH norms and disciplinary action initiated in case of failure to follow laid down SOP with regards to washing hands, insisting on the patients who come to wash hands and follow protocol as well as regarding wearing Masks.
- The asset for hand wash has not been provided. Running water connectivity and proper drainage for 2 wash basins provided and used properly. Sensitization of the staff on its importance and utilization must be insisted and followed up.
- Ramp for handicapped persons provided.

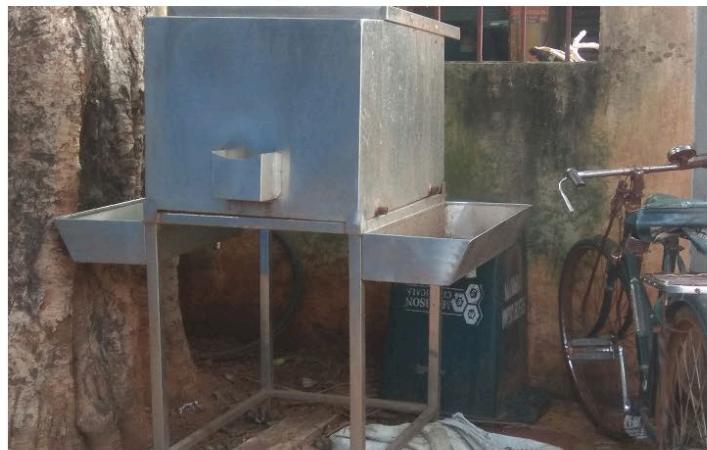
## Handwash

#	Issues addressed	Remark
1	Hand wash facility and type	Conventional tap with soap
2	Number of outlets	2
3	Condition	The hand wash apparatus has been provided for this UPHC but not being used. This may pose a health hazard also.

- Staff must be trained as well as supervised to adhere to WaSH norms and disciplinary action initiated in case of failure to follow laid down SOP with regards to washing hands, insisting on the patients who come to wash hands and follow protocol as well as regarding wearing Masks.
- The asset for hand wash has been provided but not being used. Running water connectivity and proper drainage for wash basins not provided. Sensitization of the staff on its importance and utilization must be insisted and followed up.
- Ramp for handicapped persons provided.

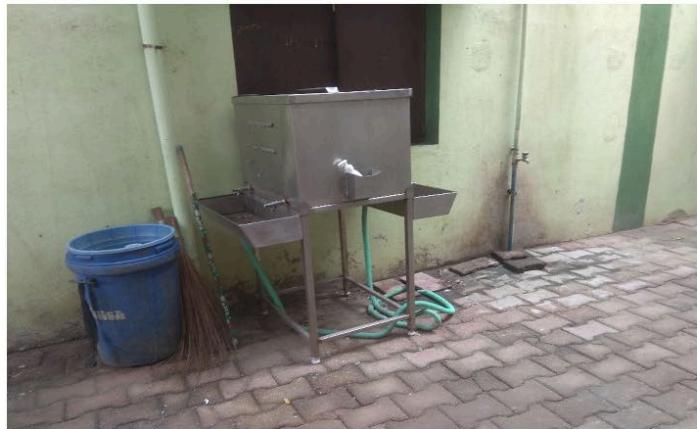
Handwash

#	Issues addressed	Remark
1	Hand wash facility and type	Conventional tap with soap
2	Number of outlets	4 + 1
3	Condition	The hand wash apparatus has been provided for this UPHC but not being used. One tap is being used for washing hands. This may pose a health hazard also. Proper drain facility exists.

- a. Staff must be trained as well as supervised to adhere to WaSH norms and disciplinary action initiated in case of failure to follow laid down SOP with regards to washing hands, insisting on the patients who come to wash hands and follow protocol as well as regarding wearing Masks.
- b. The asset for hand wash has been provided but not being used. Running water connectivity and proper drainage for wash basins not provided. Sensitization of the staff on its importance and utilization must be insisted and followed up.
- c. Ramp for handicapped persons provided. Metro water connectivity can be easily provided.

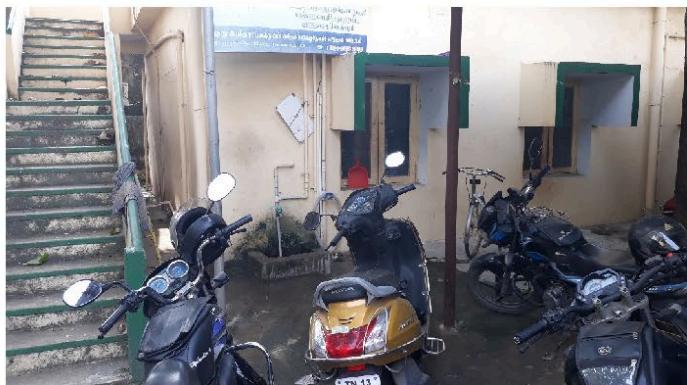
## Handwash

#	Issues addressed	Remark
1	Hand wash facility and type	Conventional tap with soap
2	Number of outlets	1
3	Condition	The hand wash apparatus has <b>not</b> been provided for this UPHC. One tap is being used for washing hands. This may pose a health hazard also. Proper drain facility exists.

- Staff must be trained as well as supervised to adhere to WaSH norms and disciplinary action initiated in case of failure to follow laid down SOP with regards to washing hands, insisting on the patients who come to wash hands and follow protocol as well as regarding wearing Masks.
- The asset for hand wash has not been provided. Sensitization of the staff on its importance and utilization must be insisted and followed up.
- Ramp for handicapped persons not provided as the entrance is on flat surface. However, facilities for them can be enhanced. Metro water connectivity can be easily provided.

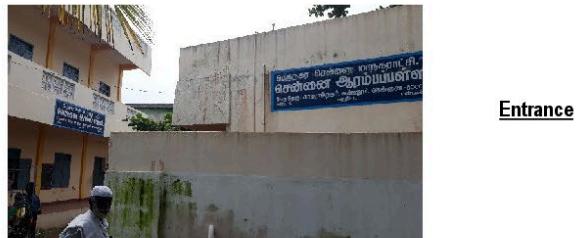
**Handwash- Entrance**

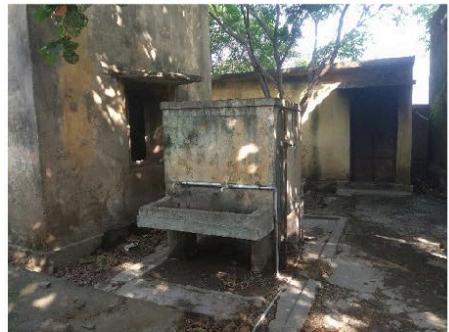
Handwash

#	Issues addressed	Remark
1	Hand wash facility and type	Conventional tap with soap
2	Number of outlets	3
3	Condition	The hand wash taps are broken / not usable.

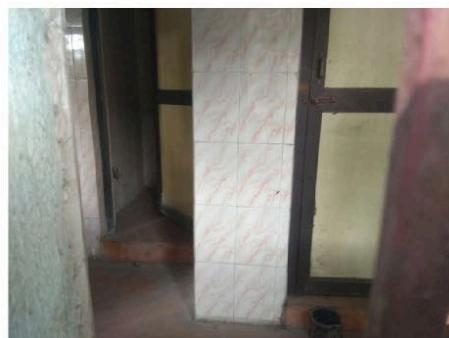
Boys Toilet

#	Issues addressed	Remarks
1	Number of toilets	For boys 3 toilets and a urinal platform For girls 6 toilets and a urinal platform
3	Privacy rooms (Menstrual Hygiene)	Not available
4	Incinerator for menstrual pads	Available
5	Separate water tank for toilet	Yes
6	Condition	Usable

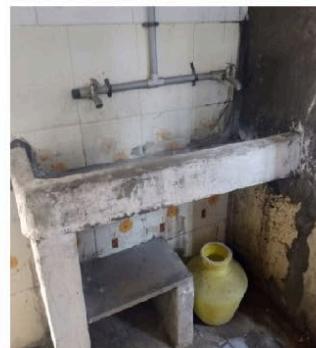
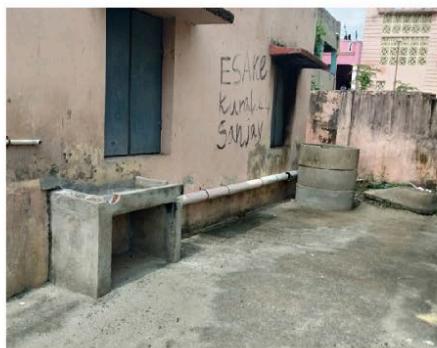
Wash Area

#	Issues addressed	Remark
1	Hand wash facility and type	Conventional tap with soap
2	Number of outlets	3
3	Condition	The hand wash taps are broken / not usable

All hand wash areas are to be designed to improve the usage once the School is reopened after the easing of the Lockdown.

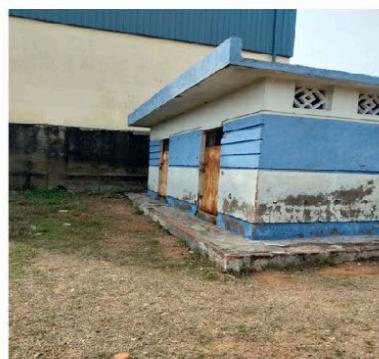
**Toilet**

#	Issues addressed	Remarks
1	Number of toilets	For boys 3 toilets and a urinal platform
		For girls 3 toilets and a urinal platform
3	Privacy rooms (Menstrual Hygiene)	Not available
4	Incinerator for menstrual pads	Not available
5	Separate water tank for toilet	No
6	Condition	Supply and sewage pipelines are broken

#	Issues addressed	Remark
1	Hand wash facility and type	Not seen
2	Number of outlets	-
3	Condition	Unable to see as the Toilets were locked. Outside taps and handwash were broken and requires repair and upkeep before school reopens.

This area shall require interventions on priority as this is in one of the poorest part in Zone 1 as well as not in a safe area as seen from various aspects of the school maintenance.

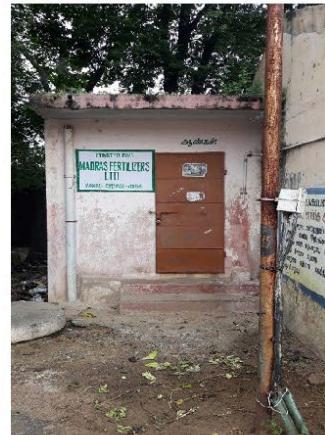
Boys Toilet

#	Issues addressed	Remarks
1	Number of toilets	For boys 1 toilet and 0 urinal platform For girls 1 toilet and 0 urinal platform
3	Privacy rooms (Menstrual Hygiene)	Not applicable
4	Incinerator for menstrual pads	Not Applicable
5	Separate water tank for toilet	No
6	Condition	Usable

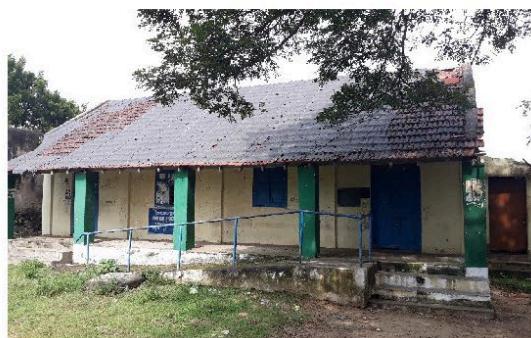
Boys and Girls Toilet

Very poor building condition with huge roof leak

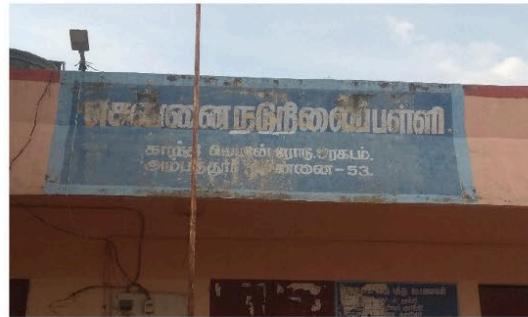
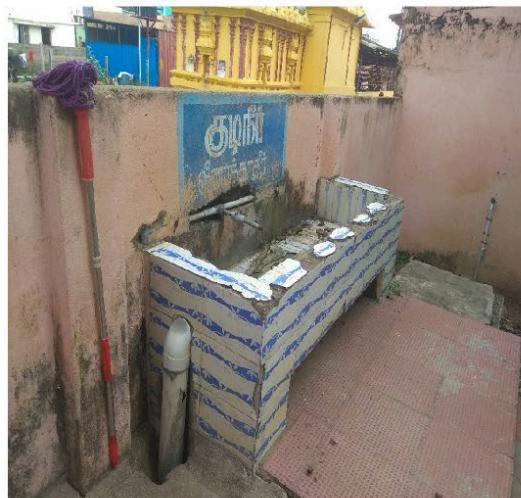
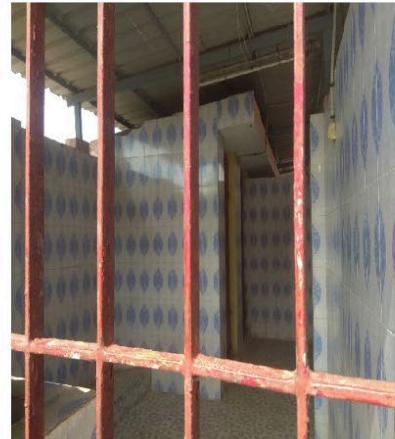
Zone	07 - Ambattur
Division	79
School Name	CMS
Location	Gandhi Main Road, Oragadam

#	Issues addressed	Remarks
1	Number of toilets	For boys 1 toilet and 0 urinal platform For girls 2toilet and 0 urinal platform
3	Privacy rooms (Menstrual Hygiene)	Not available
4	Incinerator for menstrual pads	Not available
5	Separate water tank for toilet	No
6	Condition	Not usable

#	Issues addressed	Remark
1	Hand wash facility and type	Conventional tap with soap
2	Number of outlets	0
3	Condition	The entire facility is broken including the washbasin due to poor upkeep. Security of assets need to be looked in to and innovative methods adopted to ensure optimum utilization of deployed assets.

#	Issues addressed	Remark
1	RO water tank	No
2	Number of drinking outlets	Not applicable
3	Condition	Not available. The school staff draw water from a nearby Metro water tank.

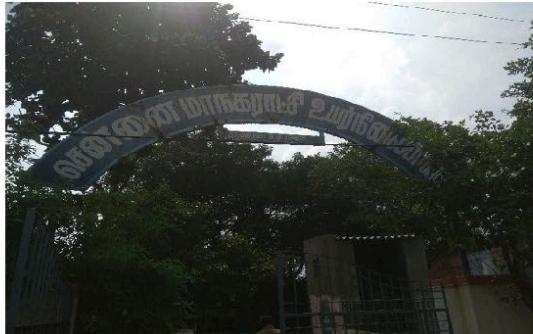
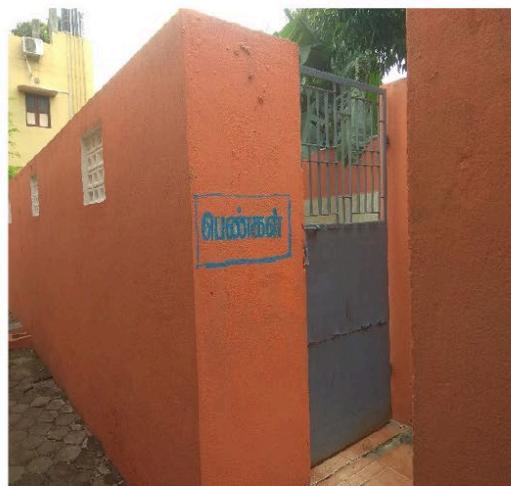
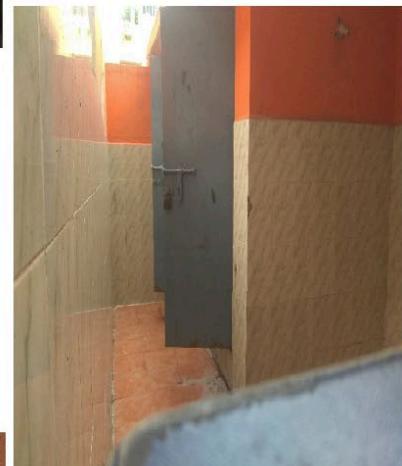
Zone	07 - Ambattur
Division	81
School Name	CMS
Location	Chozhapuram, Ambattur

#	Issues addressed	Remarks
1	Number of toilets	For boys 3 toilet and 1urinal platform For girls 3toilet and 2 urinal platform
3	Privacy rooms (Menstrual Hygiene)	Not available
4	Incinerator for menstrual pads	Not available
5	Separate water tank for toilet	No
6	Condition	Usable

#	Issues addressed	Remark
1	Hand wash facility and type	Conventional tap with soap
2	Number of outlets	4
3	Condition	The hand wash taps are broken and not usable.

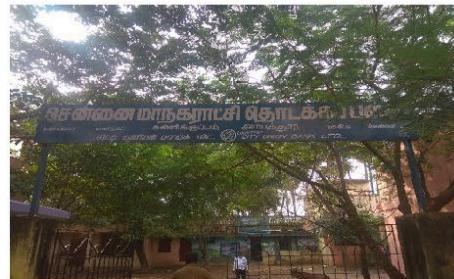
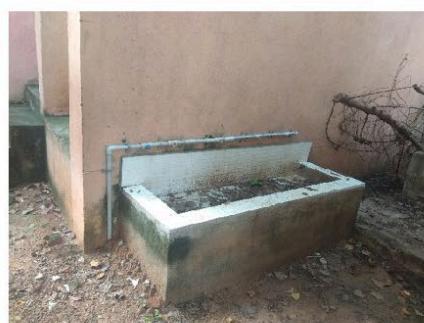
Zone	07 - Ambattur
Division	82
School Name	CHS + CPS
Location	Padasalai Street, Kallikuppam

#	Issues addressed	Remarks
1	Number of toilets	For boys 4 toilet and 3urinal platform For girls 5toilet and 3 urinal platform
3	Privacy rooms (Menstrual Hygiene)	Not available
4	Incinerator for menstrual pads	1 not working
5	Separate water tank for toilet	No
6	Condition	Usable

#	Issues addressed	Remark
1	Hand wash facility and type	Conventional tap with soap
2	Number of outlets	3
3	Condition	The hand wash taps are not working/ not usable. Security of assets to be deployed must be kept in mind at the design stage to ensure optimum utilization in the longer run.

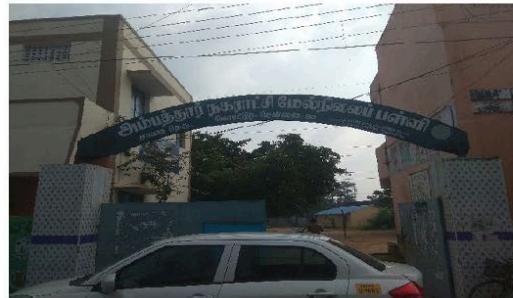
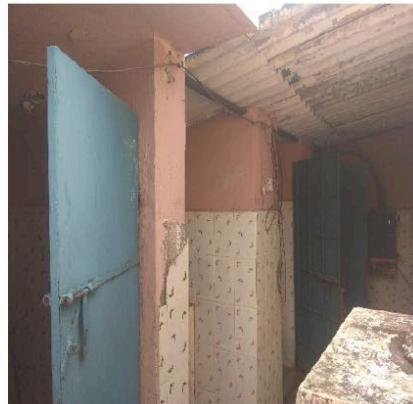
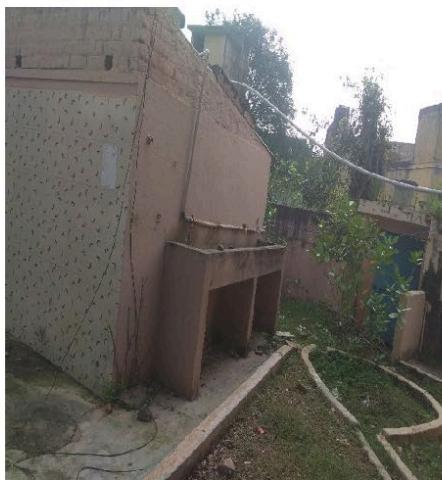
Zone	07– Ambattur
Division	84
School Name	CHS + CPS
Location	Chavadi Street, Korattur

#	Issues addressed	Remarks
1	Number of toilets	For boys 3 toilet and 1 urinal platform For girls 5 toilet and 6 urinal platform
3	Privacy rooms (Menstrual Hygiene)	Not available
4	Incinerator for menstrual pads	1 not working
5	Separate water tank for toilet	Yes
6	Condition	Usable

#	Issues addressed	Remark
1	Hand wash facility and type	Conventional tap with soap
2	Number of outlets	6
3	Condition	The hand wash taps are not working/ not usable. Future design must include to ensure security of assets deployed with assigned responsibilities.

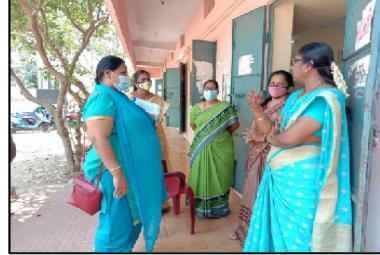
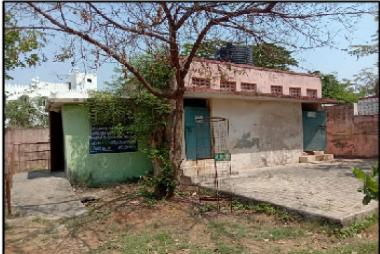
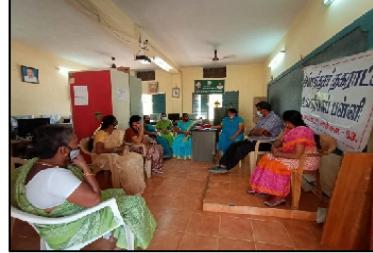
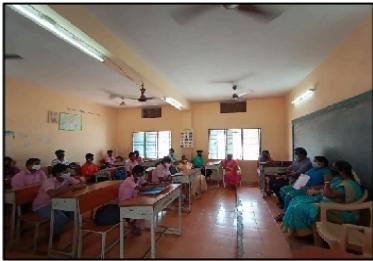
**C. Summary of Public Consultations along with photographs at Ambattur Municipal High School, Kamarajapuram, Chennai-53**

<p>Toilet door was broken, No proper lighting and ventilation inside the toilets.</p> <p>Hand wash- 5 taps were there and 4 were broken.</p> <p>Water- Due to lock down, water tank was not cleaned and Students bring water from their home.</p> <p>First aid kit not available</p> <p>Economic status- While having student interaction, children shared their parents work activities. Most of them are daily earners, painters, Watch man, Welder, Corporation contract scavengers (Adi Andra community).</p> <p>Primary health center- They visit school 2 months once and conduct medical screening. Every Thursday Folic acid tablet was distributed. 6 month once deworming tablets were given. 1 eye camp conducted. 20 students were given spectacles.</p>	<ul style="list-style-type: none"> <li>Hand wash facilities along with adequate sanitizers / soaps for all will placed.</li> <li>Awareness on personal health and hygiene of the students (including adolescent girl students) are one of the main targets of the project.</li> </ul>

Date & Location	No. of Participants	Topics/Concerns / Issues discussed	Issues Addressed	Photographs
03.03.21 Ambattur Malligai, Municipal Ambattur Municipal high school, Kamarajapuram	<p><b>Female Teachers- 7</b></p> <p><b>Students-18</b></p> <p>Boys- 12</p> <p>Girls- 6</p> <p>Total participants : 25</p> <p>Male: 12 (48%)</p> <p>Female: 13 (52%)</p>	<ul style="list-style-type: none"> <li>The consultation was carried out by AEE, Head mistress, School teachers, students and facilitated by Social Safeguard Specialist</li> <li>Covid protocols were followed during consultation meeting.</li> <li>Children come from nearby areas like Nehru nagar, Kamarajapuram and MKB nagar. were also explained by the consultant</li> <li>Toilets- 1 unit each for boys and girls (2 Toilets and 5 urinals) 1 disability toilet was used by teachers, since there is no disabled student in school. Toilet found to be unclean and with foul smell inside. Corporation staff comes and cleans toilet every morning, later in afternoon there is no one to clean it.</li> </ul>	<p>Based on the issues raised by the teachers and students group; it has been responded to the participants that; some of the major issues associated with construction related activities like creation of new class rooms, structural maintanances, safety and security of common propoerty resources within the school campus during holidays etc. will be communicated to the officials of GCC.</p> <p>However; based on scope of work under the ADB funded proposed project issues like</p> <ul style="list-style-type: none"> <li>Provision of renovation and creation of new bio friendly toilets has been planned.</li> <li>Water supply system will be upgraded as per plan.</li> </ul>
